Unit 05: Tips and Tricks/Advanced Techniques

WEB-BASED FLOOD INUNDATION MODELING WITH DSS-WISE WEB: A
SHORT COURSE ON RECENT UPDATES WITH HANDS-ON TRAINING

Technical Workshop

NATIONAL CENTER FOR COMPUTATIONAL HYDROSCIENCE AND ENGINEERING
THE UNIVERSITY OF MISSISSIPPI

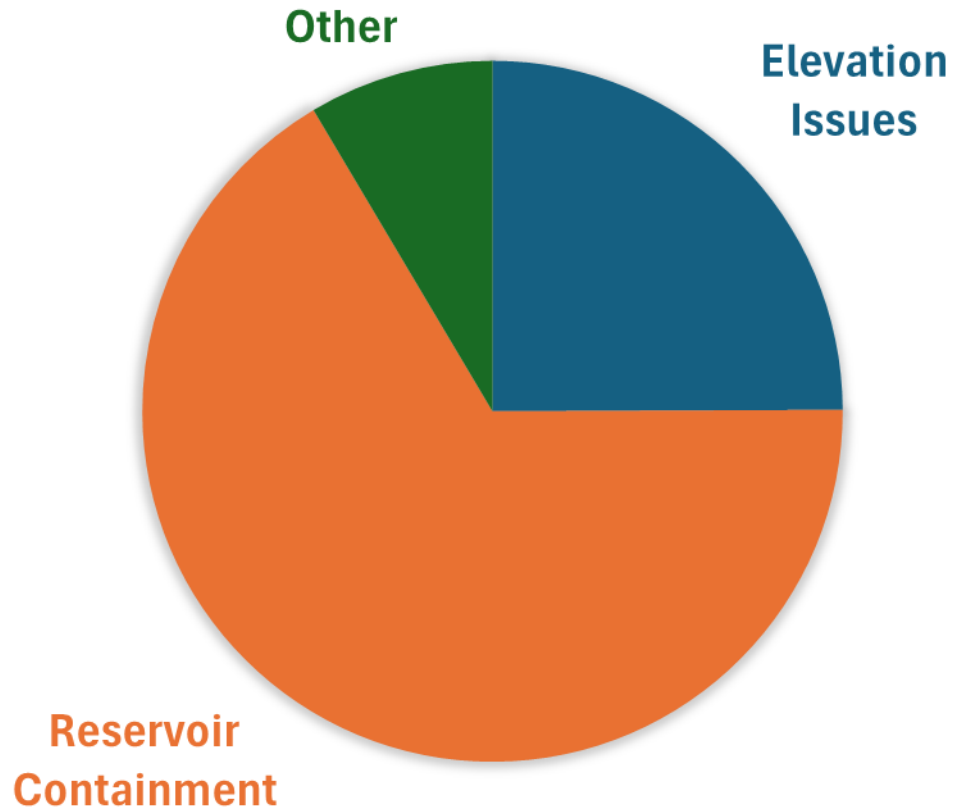
MOST FREQUENT SIMULATION ERRORS

- The most common issues are caused by errors in elevation data entered by the user or a mismatch with the DEM data. In reservoir type simulations the user is asked to provide the crests elevations of all impounding structures, maximum storage elevation of the reservoir, normal pool elevation of the reservoir, the failure elevation of the reservoir, and the breach invert elevation.
- The National Inventory of Dams (NID) does not contain any elevation information. Often, the users do not have the elevation data for the dam they are simulating. They try enter guessed values, which are often wrong.

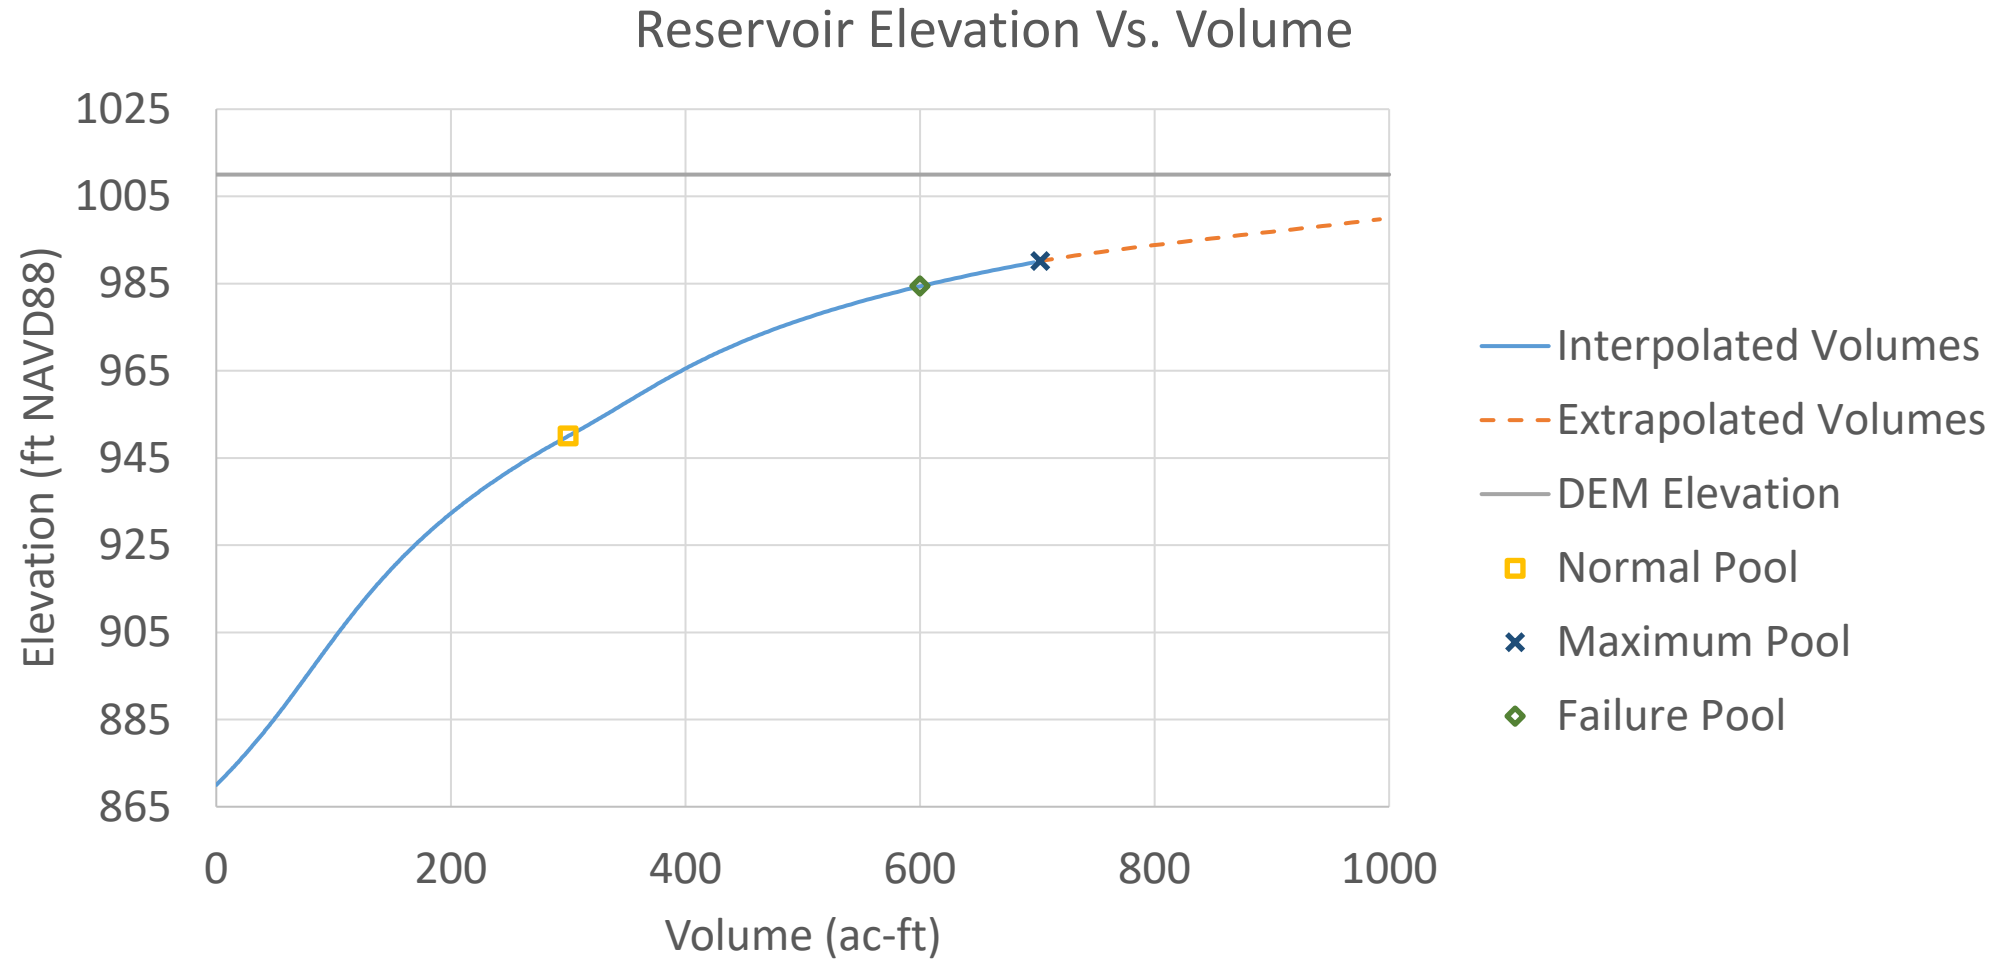
Reservoir Volume Interpolation/Extrapolation

Elevation in DEM at Reservoir Point is outside the elevations given for the reservoir, and is also too high to be extrapolated. This will result in an error.

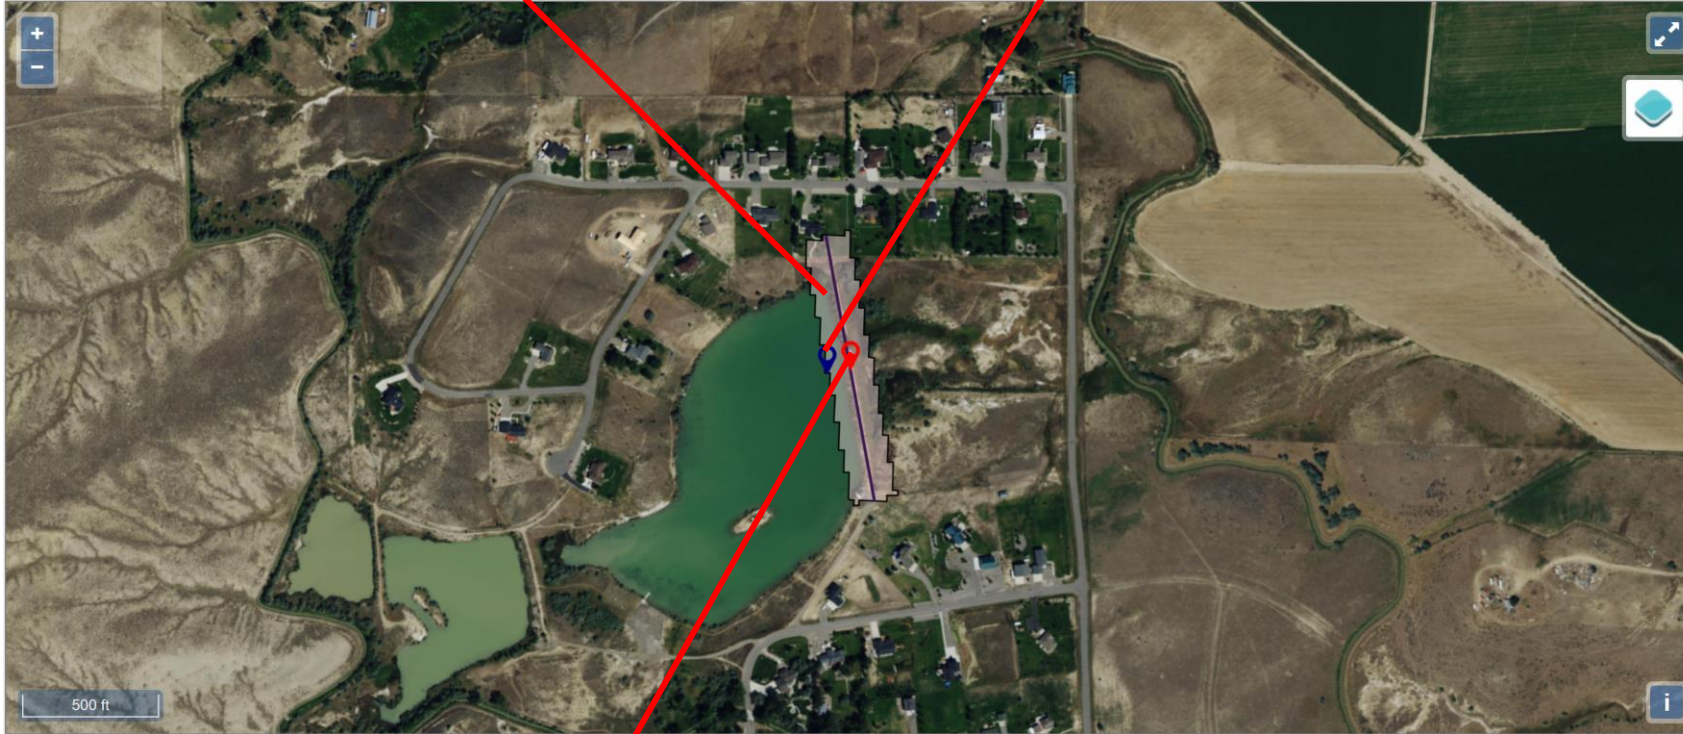
Footprint of the impounding structure

Reservoir Point.

Too close to the structure footprint!

Job Status	User Error
Error	<p>ELEVATION FOUND IN DEM IS TOO HIGH RELATIVE TO THE GIVEN RESERVOIR INFORMATION: The reservoir volume at elevation 3,382.1 ft is required in order to estimate its bathymetry. The system tries to estimate the volume at this elevation using the given maximum, normal, and failure pool data. None of the given reservoir pool elevations were high enough to properly estimate the required volume, so the system was unable to estimate reservoir bathymetry and had to abort. Please review input data. ?</p>

Reservoir point placed too close to the impounding structure, which may cause issues.

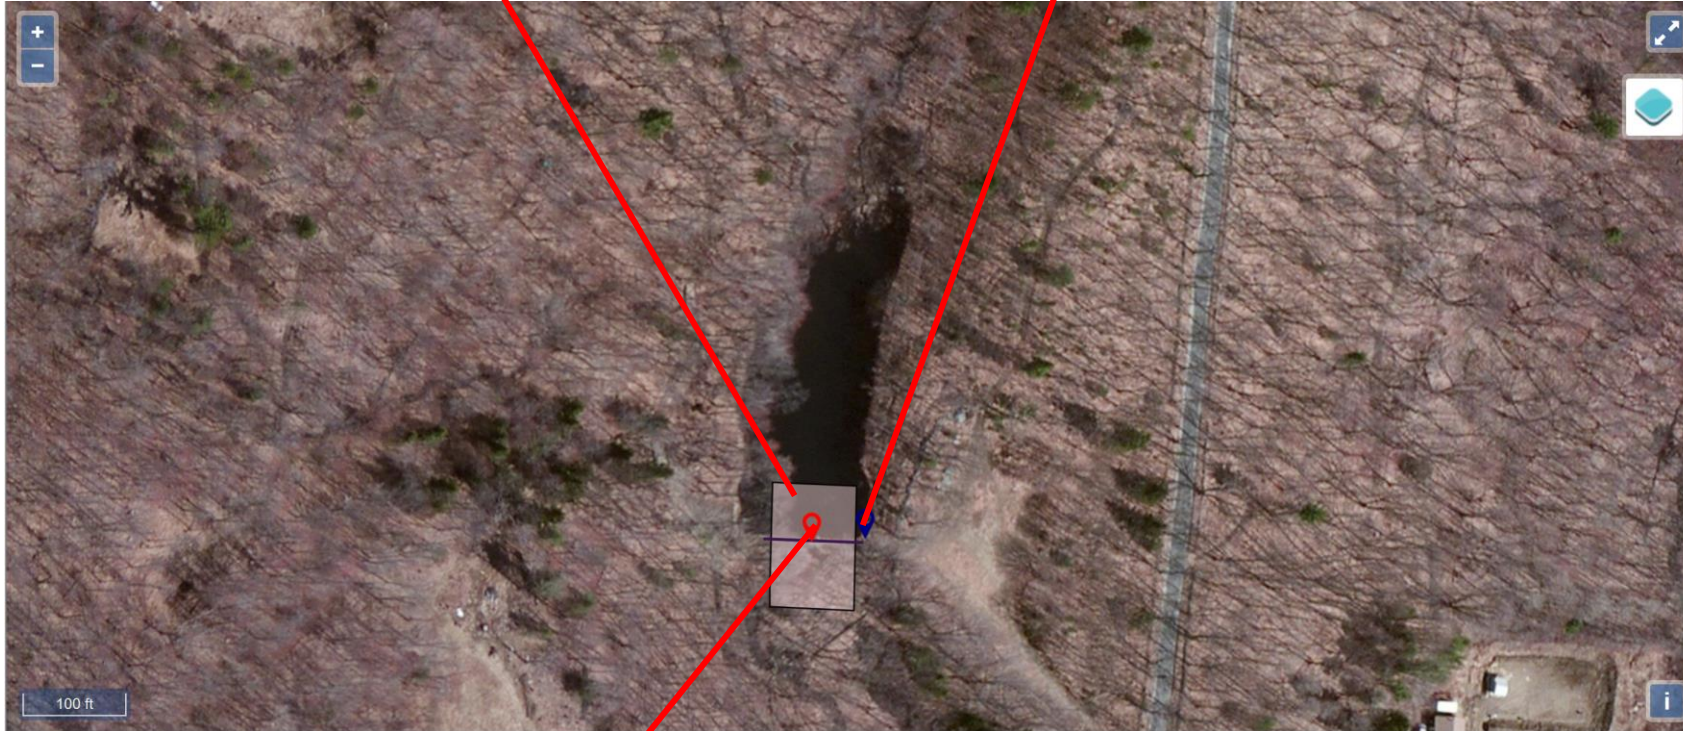
Footprint of the impounding structure

Reservoir Point.

Note that it is not correctly located!

ELEVATION FOUND IN DEM IS TOO HIGH RELATIVE TO THE GIVEN RESERVOIR INFORMATION: The reservoir volume at elevation 793.99 ft is required in order to estimate its bathymetry. The system tries to estimate the volume at this elevation using the given maximum, normal, and failure pool data. None of the given reservoir pool elevations were high enough to properly estimate the required volume, so the system was unable to estimate reservoir bathymetry and had to abort. Please review input data. ?

Very narrow reservoir, with the reservoir point too close to the structure. The system will try to move it away, but it is not always successful in preventing the error.

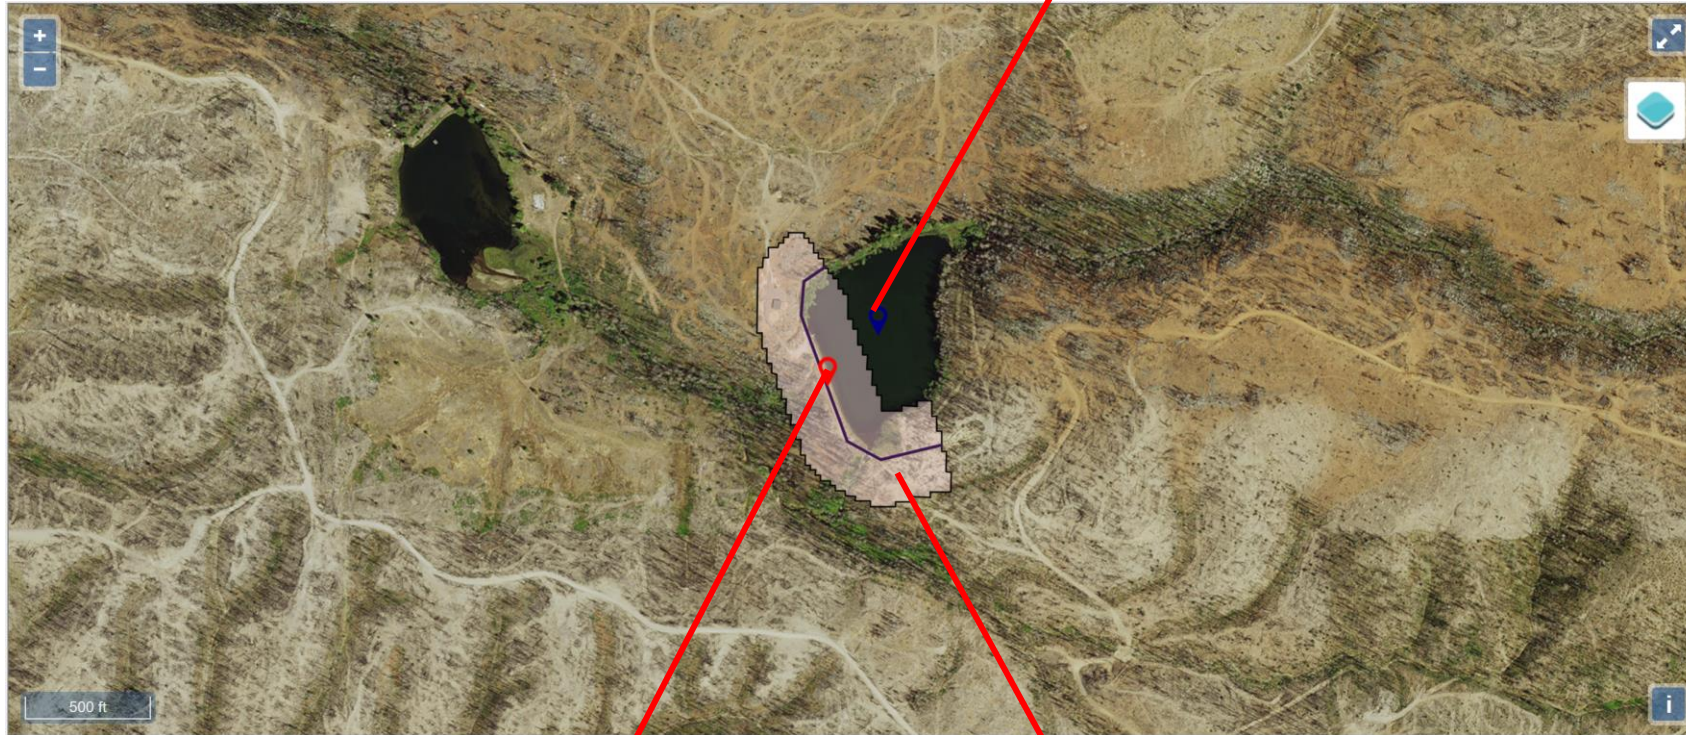
Reservoir Point.

Footprint of the impounding structure

Job Status	User Error
Error	<p><u>ELEVATION FOUND IN DEM IS TOO HIGH RELATIVE TO THE GIVEN RESERVOIR INFORMATION: The reservoir volume at elevation 3,362.1 ft is required in order to estimate its bathymetry. The system tries to estimate the volume at this elevation using the given maximum, normal, and failure pool data. None of the given reservoir pool elevations were high enough to properly estimate the required volume, so the system was unable to estimate reservoir bathymetry and had to abort. Please review input data.</u> ?</p>

Very small reservoir, which may not be accurately represented in the DEM.

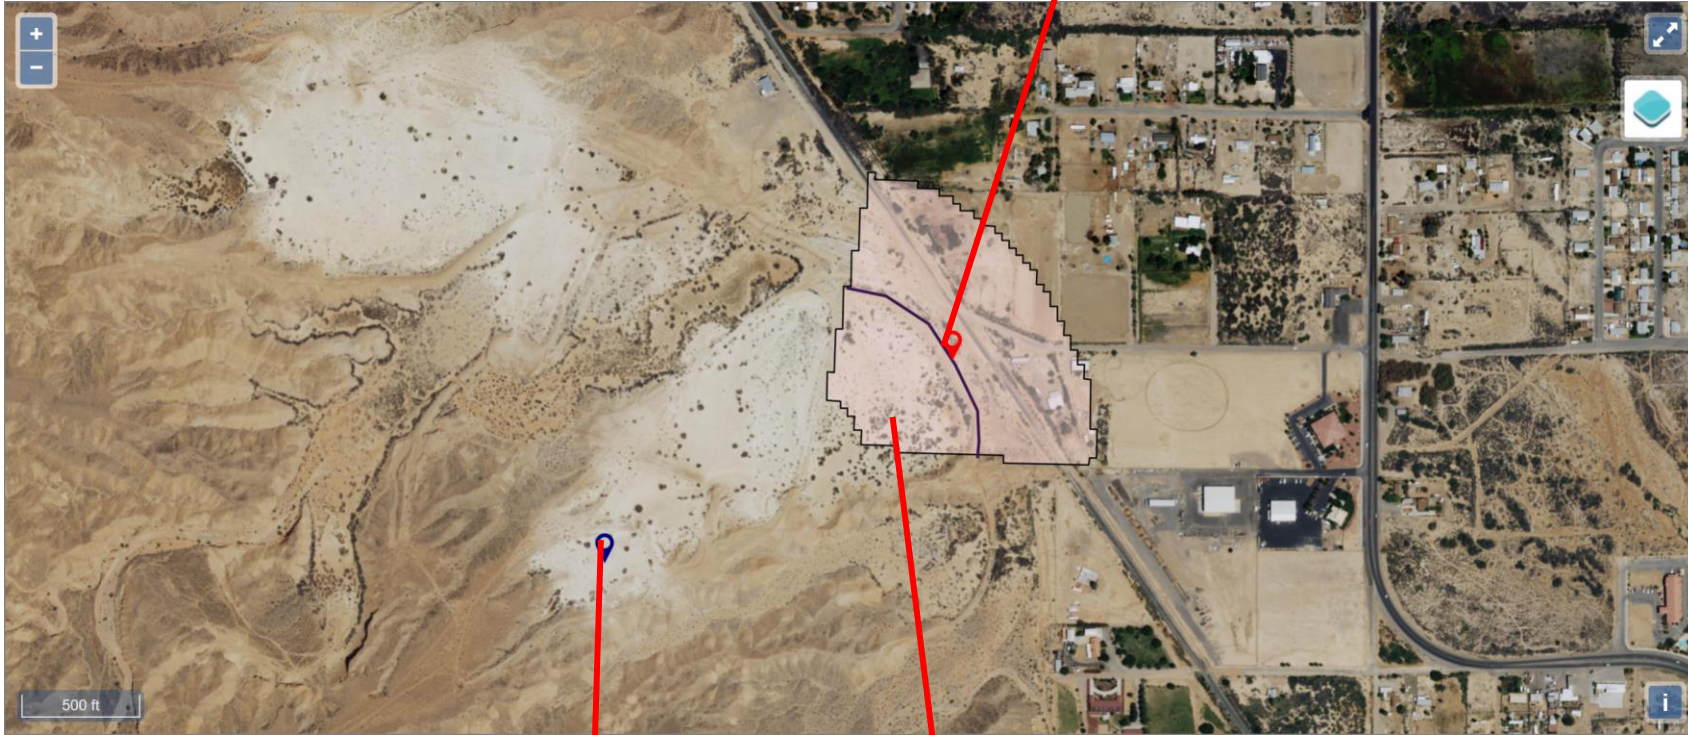
Reservoir Point

Footprint of the impounding structure

ELEVATION FOUND IN DEM IS TOO HIGH RELATIVE TO THE GIVEN RESERVOIR INFORMATION: The reservoir volume at elevation 1,348.5 ft is required in order to estimate its bathymetry. The system tries to estimate the volume at this elevation using the given maximum, normal, and failure pool data. None of the given reservoir pool elevations were high enough to properly estimate the required volume, so the system was unable to estimate reservoir bathymetry and had to abort. Please review input data. ?

Flood control reservoir, which is normally dry. Either the user provided incorrect elevations, or the DEM may have issues in this area.

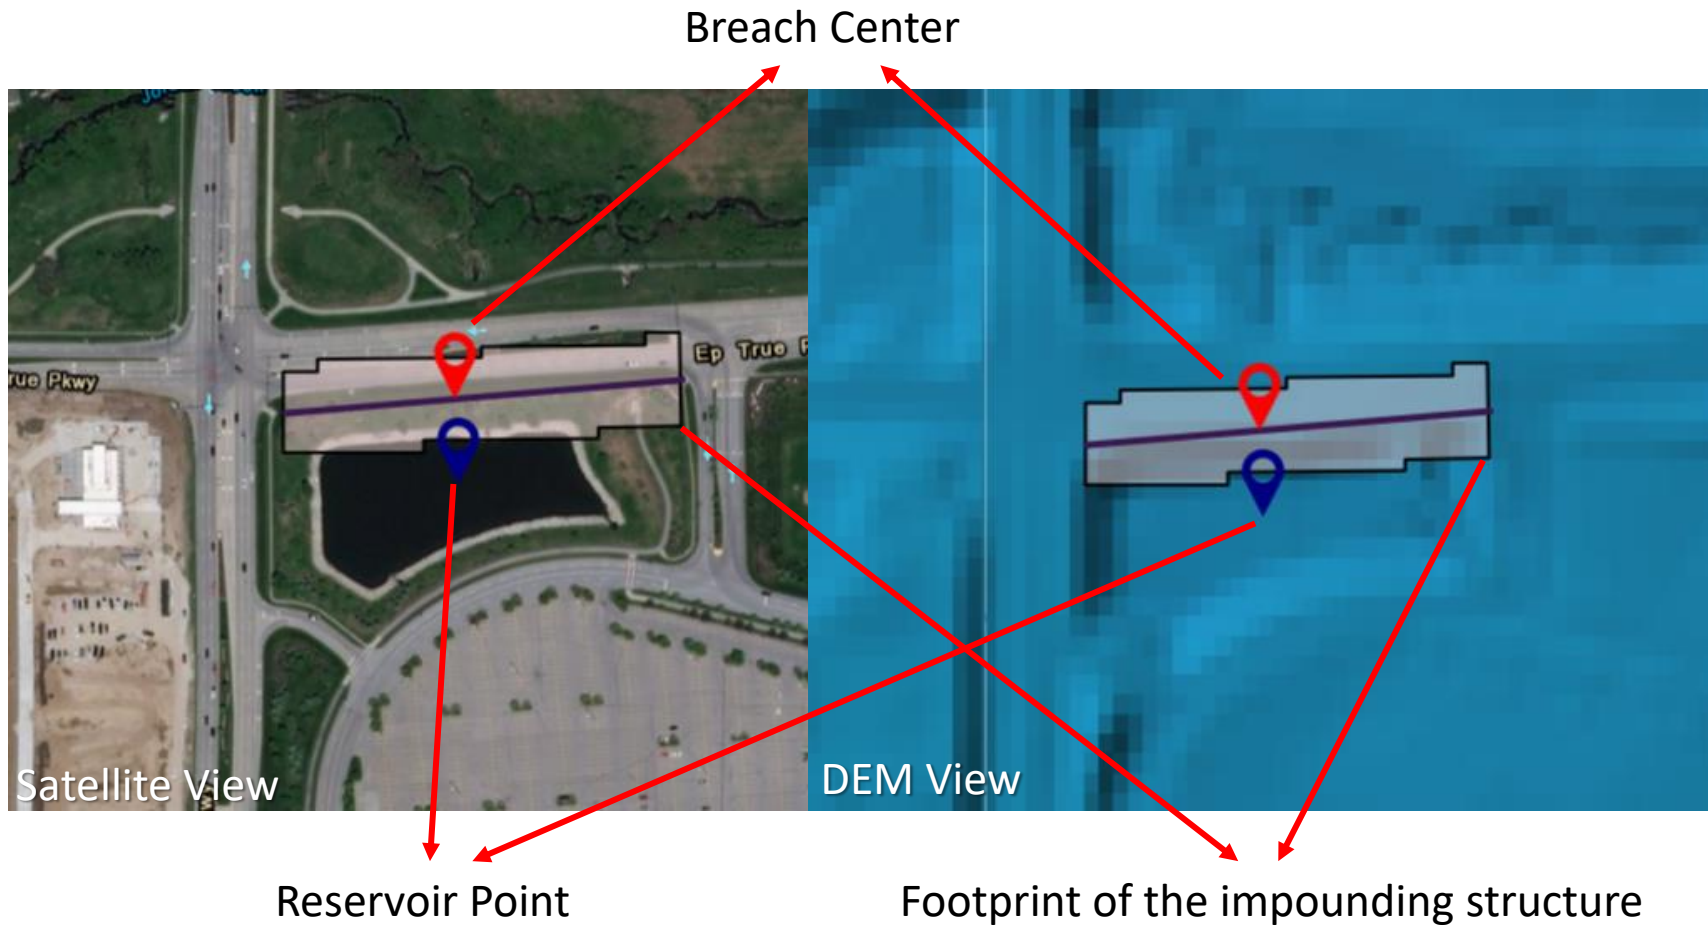
Job Status	User Error
Error	REMOVING DAM STRUCTURE(S) DOES NOT RELEASE WATER: The system has determined that even if all the structures associated with reservoir 1 are removed, the water would not flood a significant area. This is usually caused by incorrect reservoir elevations or impounding structure elevations, incorrect structure placement, or high topography downstream of the breached structure(s). Please review input data. ?

The road embankment just downstream of the breach prevents the water from escaping.

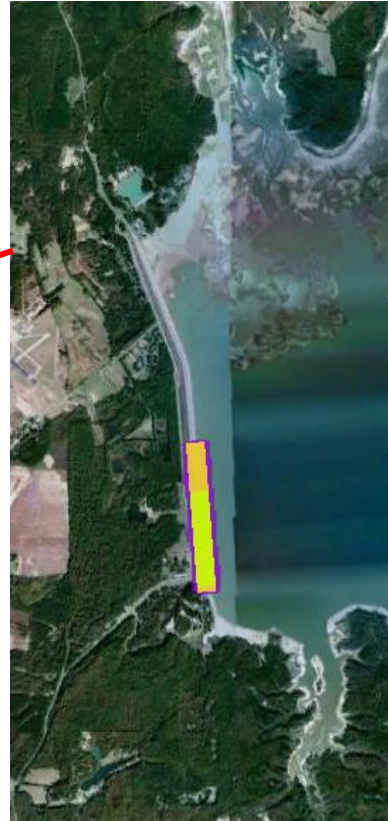
The dam is defined too short. The water leaks over the undefined part of the crest.

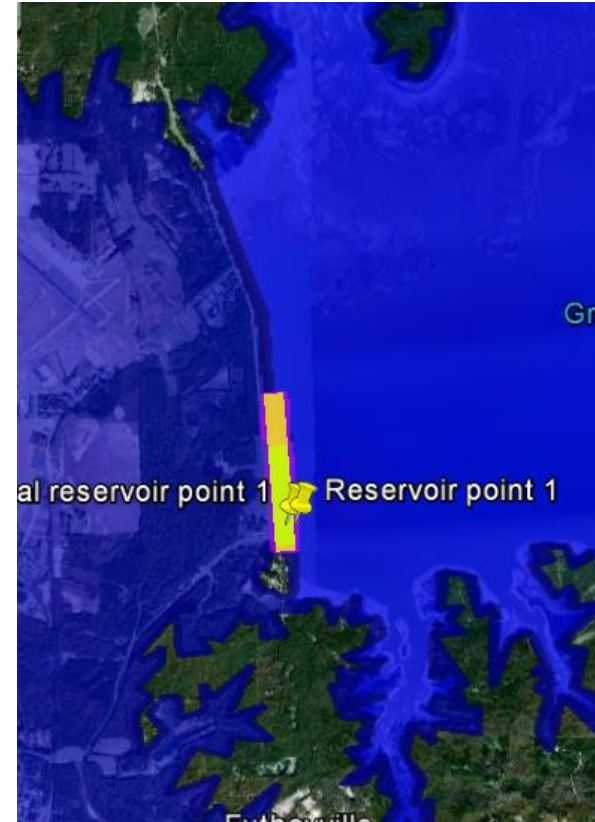
This close-up view clearly shows from where the water is leaking downstream.

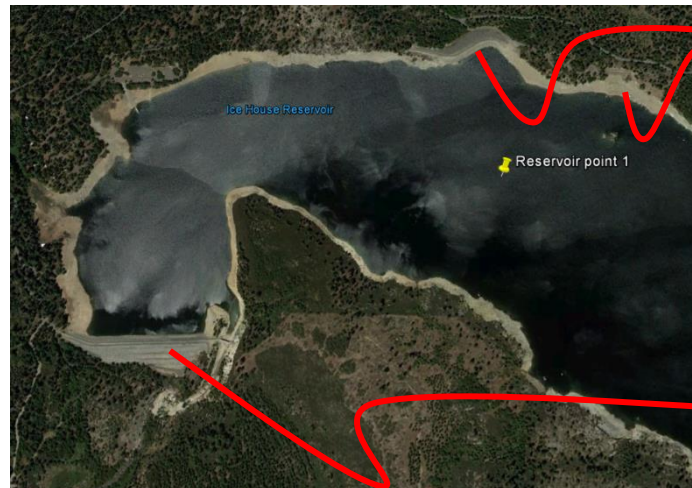
The user forgot to define these additional structures that impound the reservoir.

This dam is correctly defined.

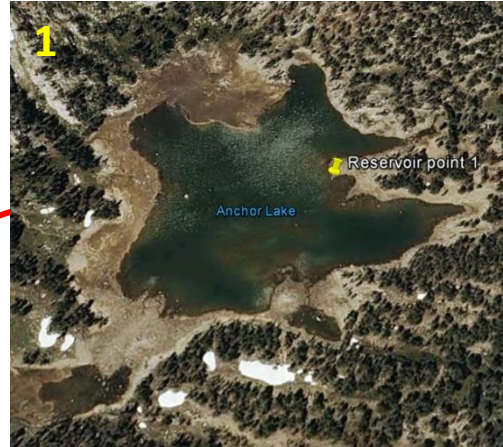
Enlarged view of the dam area.

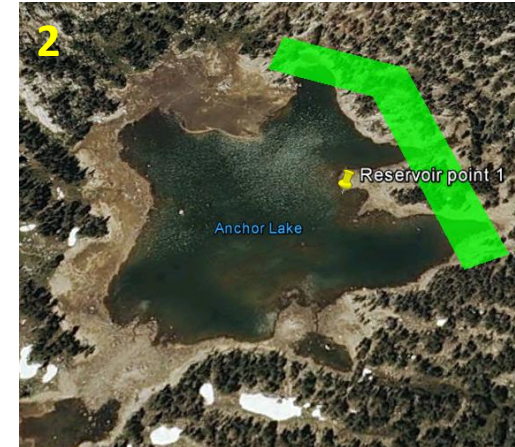
User defined dam shown in green.

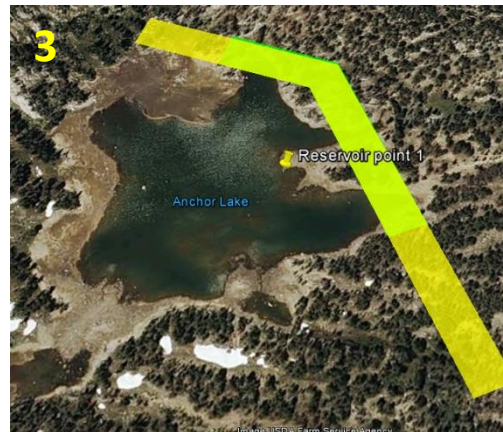
Since the user defined dam was not properly anchored DSS-WISE™ Lite extended the end points.

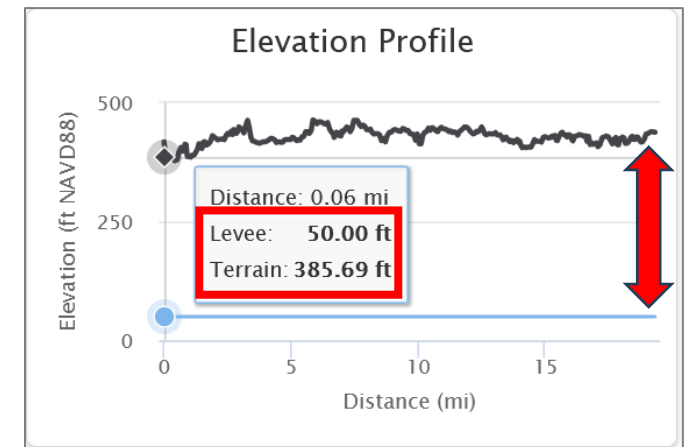
RESERVOIR'S FILLING ELEVATION IS BELOW DEM AT THAT POINT

The reservoir's bathymetry was detected to already be present in the DEM, but the given reservoir surface elevation at the failure scenario level is below the DEM's elevation. The reservoir cannot be filled to this underground elevation.

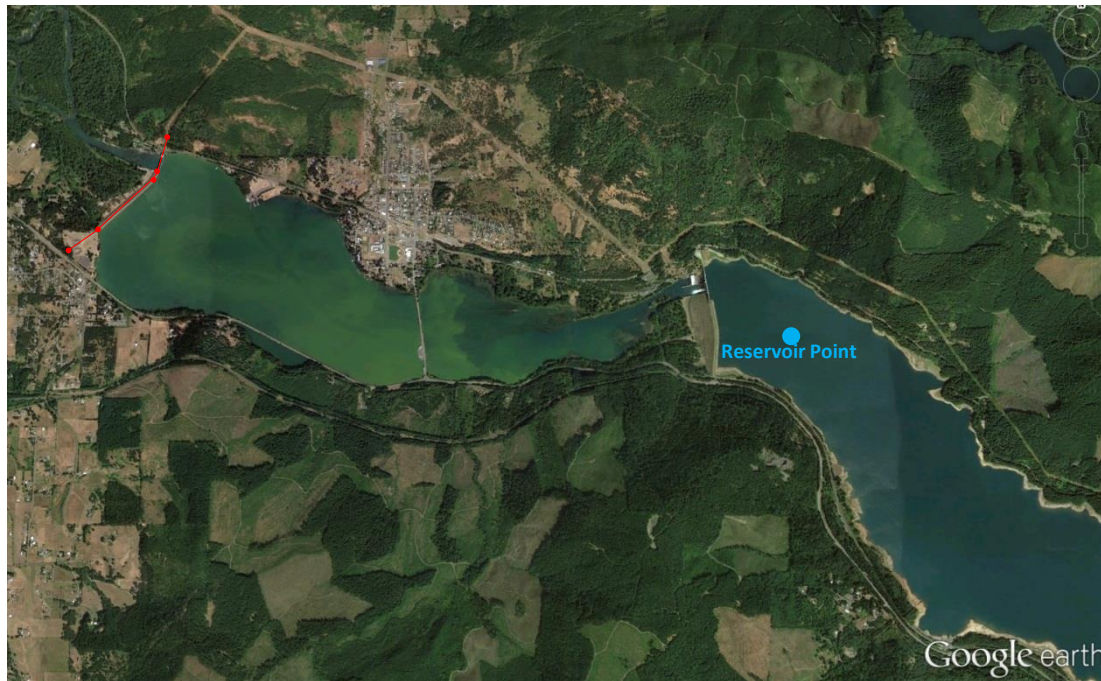
This error occurs when the user digitizes the axis of a dam and clicks the reservoir point in a reservoir not connected with the digitized dam.

When DSS-WISE fills the reservoir up to the elevation Z_{fail} , the water does not touch the dam cells. This situation is caught and the user is sent an error message.

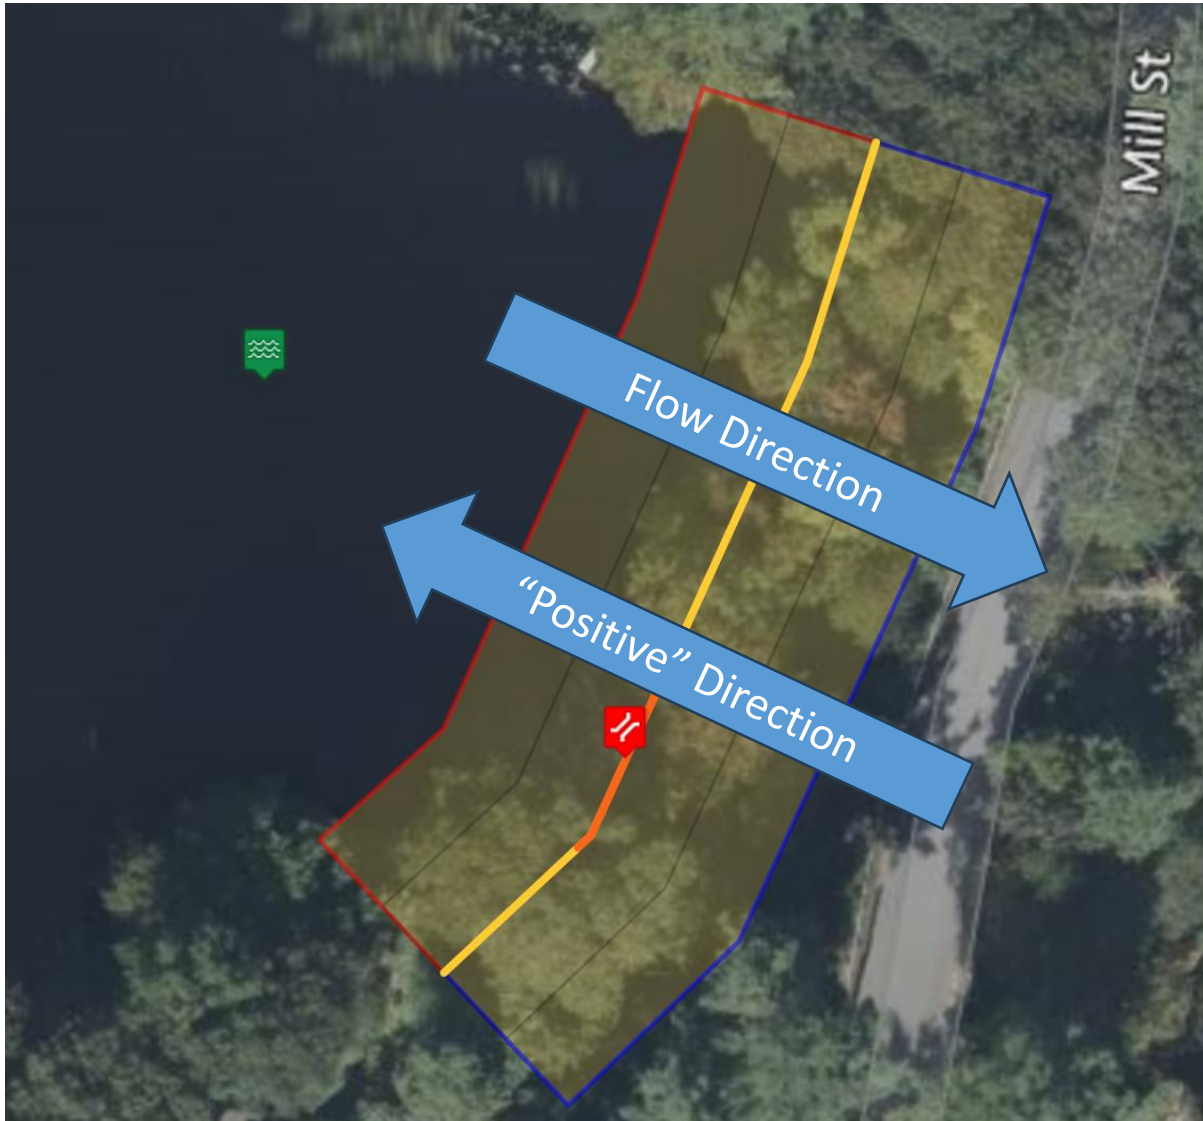
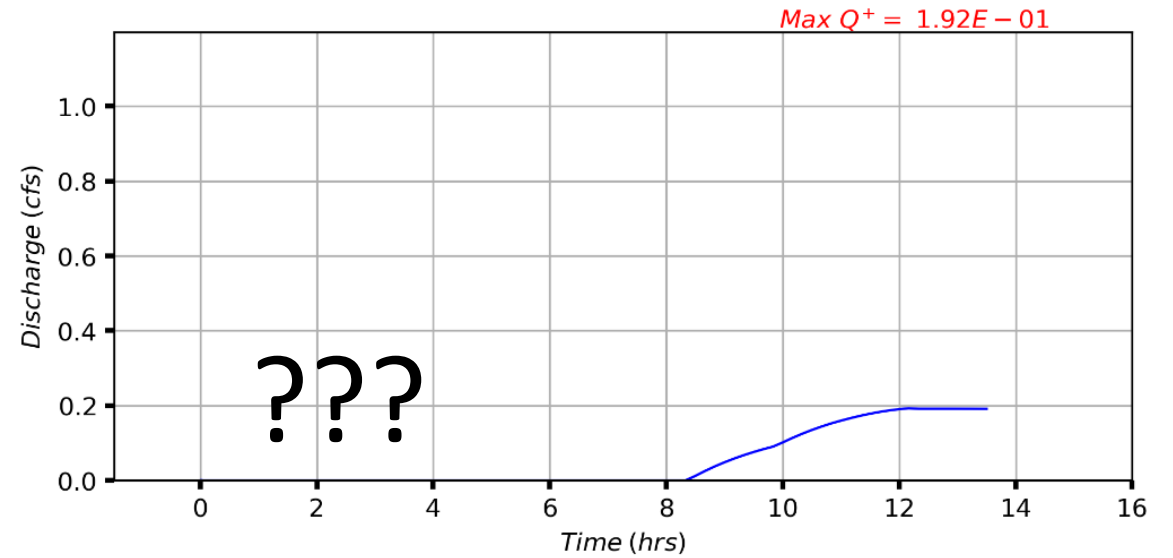
Negative Discharge

- Dam is defined with downstream direction on reservoir side
- Resulting breach discharge is reported as negative
